Re: Old Town Hall Building – Structural Assessment
1 Milton O Fountain Way
Warren MA 01083

This letter is a structural assessment of the Old Town Hall building located at 1 Milton O Fountain Way and addresses the Foundation, Masonry Walls, Floors, Roof and the Clock Tower. Attached to this letter are captioned photos, cost estimates for the building renovation per current code to the former use group of each floor, being Business use on the first floor and Assembly use for the public on the second floor, as requested an estimate for the demolition of the building is included on the last page.

Structural Assessment:

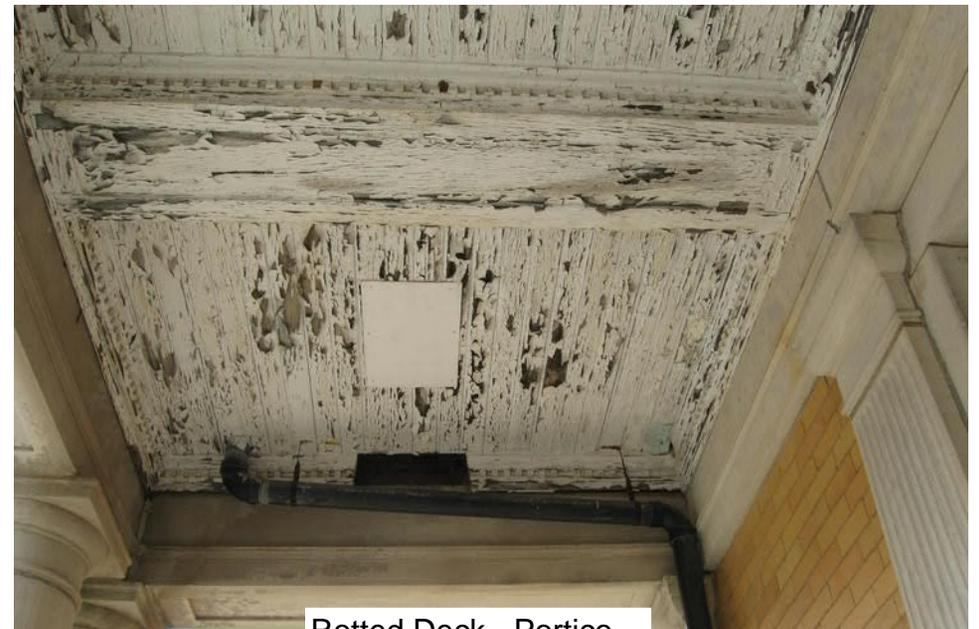
- c. The limestone columns at the main entrance Portico are in reasonably good shape with some joints requiring repointing. The Portico limestone should be cleaned as should all the face brick on the building. It was noted that the wood roof deck of the portico is rotted and should be replaced.

Rotted Deck - Portico

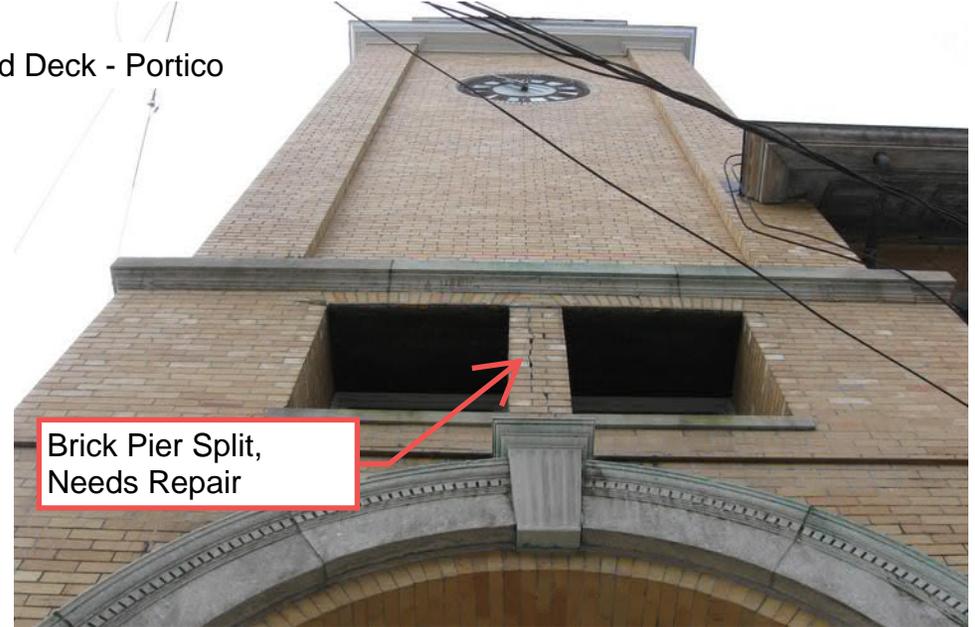
IMG_2811

- a. The brick on the North (Main Street) side from the Northeast corner at the Clock Tower is cracked/broken in many places and in need of repair. Refer to attached photo's #2811 thru 2814 showing various types of damage to the existing brick work requiring reconstruction. Additionally, the three facades with the yellow beige hard burned brick are stained/soiled and in need of cleaning and re-pointing as required.
